**(Final Report, Revised December 6, 2007)**

Condition Assessment  
and  
Reserve Fund Plan  
2008

**TUSCAWILLA  
HILLS**

Charles Town, West Virginia

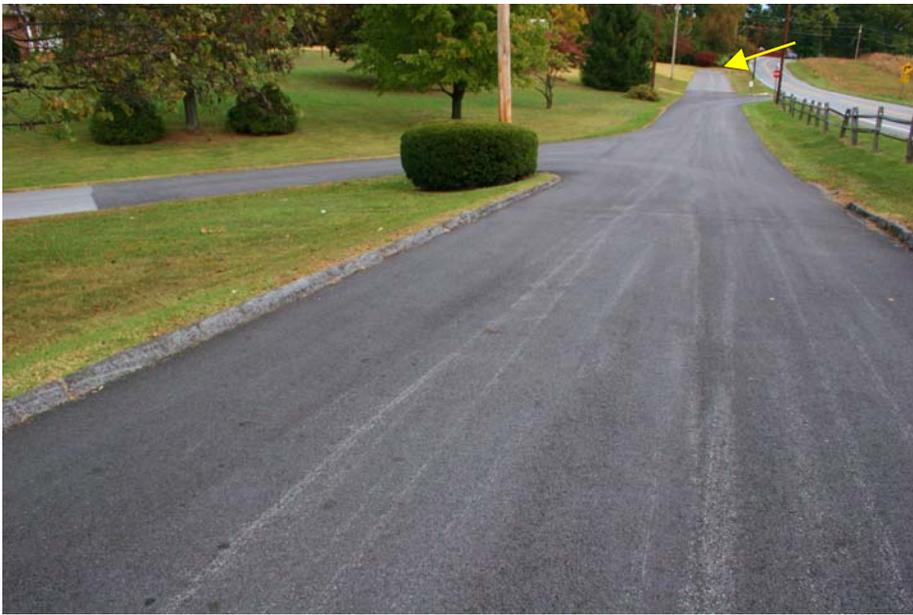
**PHOTO #1**  
Overview of the newly repaved section of Tuscawilla Drive at Summit Point Mail Station in good condition. The end of the street (arrow) is in poor condition and serves only one home. We have included it as common.

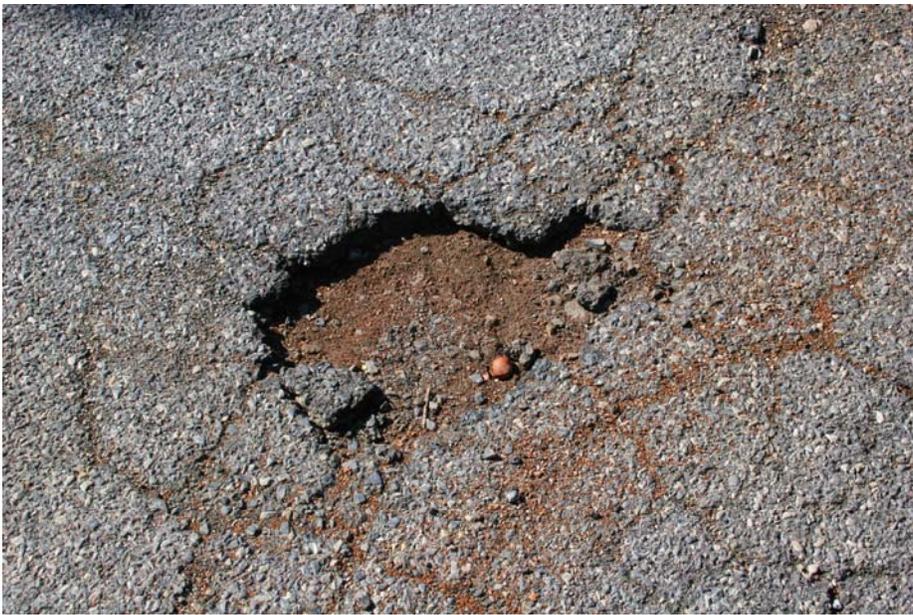
**PHOTO #2**  
This is a typical small pavement failure, of which, there are a few throughout the community that should be repaired this year (2007). See the Pavement Report for details.

**7.2 Asphalt Full-Depth Repairs:** In areas where significant alligator cracking, potholes, or deflection of the pavement surface develops, the existing asphalt surface should be removed to the stone base course and the pavement section replaced with new asphalt. Generally, this type of failure is directly associated with the strength of the base course. When the pavement is first constructed, the stone base consists of a specific grain size distribution that provides strength and rigidity to the pavement section. Over time, the stone base course can become contaminated with fine-grained soil particles from the supporting soils beneath the base course. The most positive repair to such an area is to remove the contaminated base course and replace it with new base stone to the design depth. It is appropriate to perform these types of repairs immediately prior to asphalt restoration projects. Generally, this type of repair should not be required for approximately five years after an asphalt restoration project.

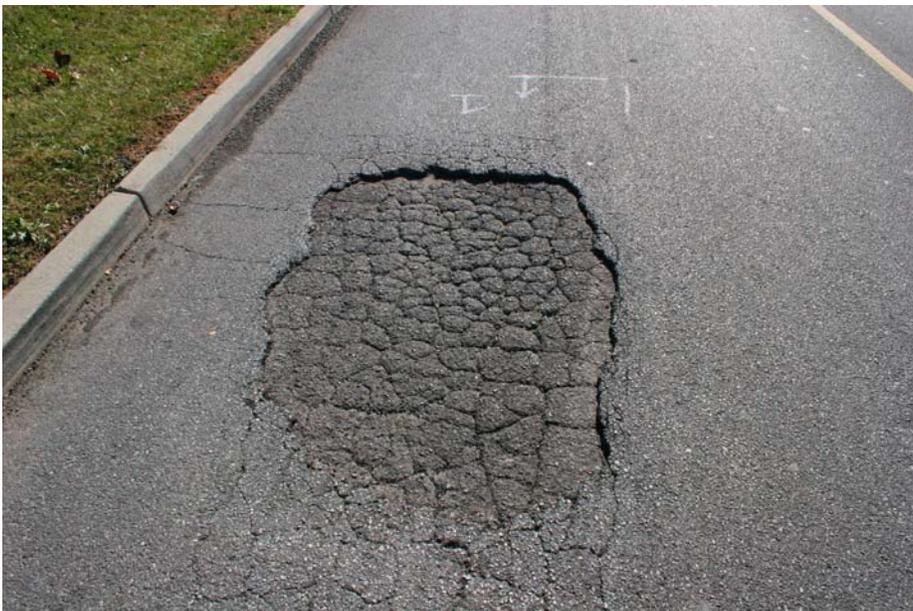
**PHOTO #3**  
There are three moderate pavement failures within Tuscawilla Drive that should be repaired this year (2007). See the Pavement Report for details.

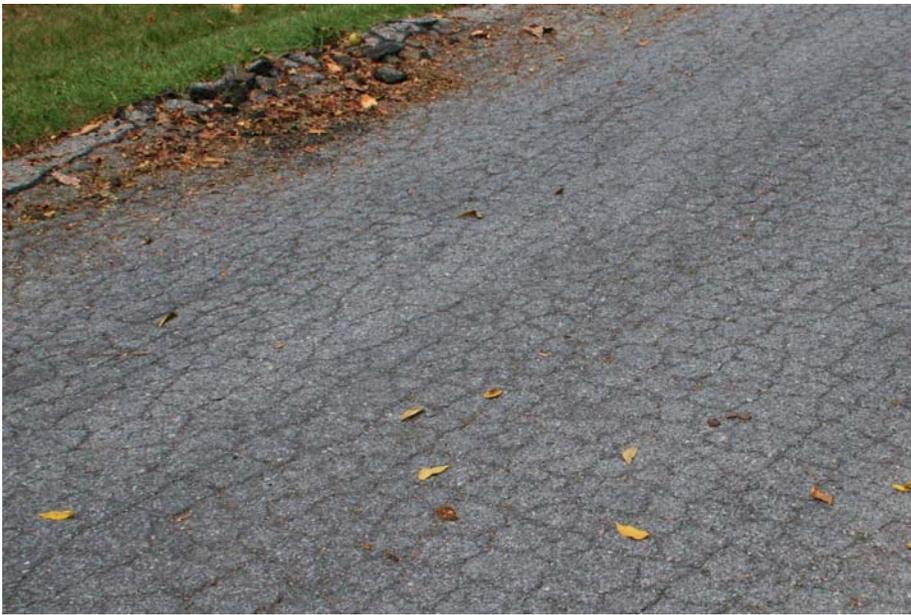
**PHOTO #4**

This full-width deflection is typical of areas that will require full milling and removal of the damaged asphalt and replacement with new 1-½" compacted asphalt.

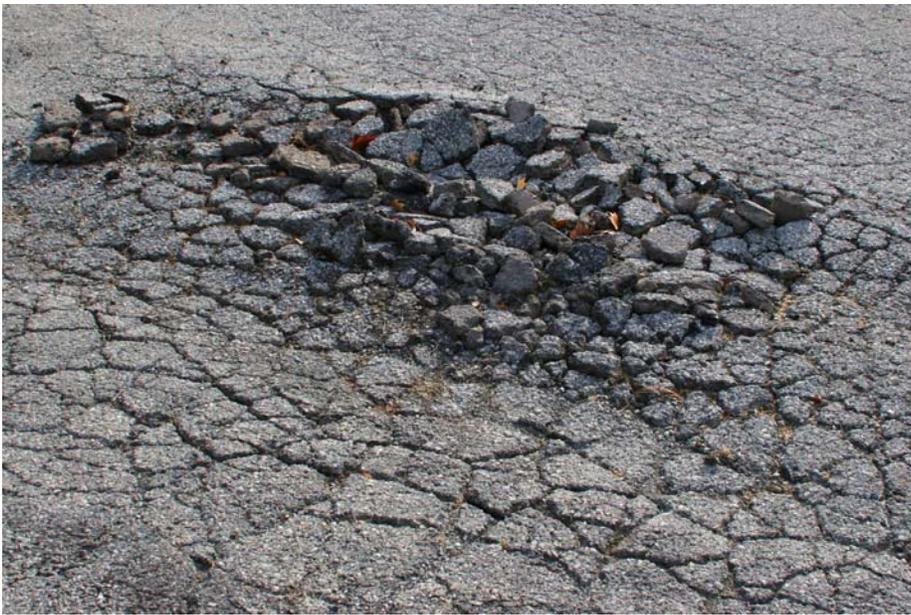
**PHOTO #5**

This area at Auburn Court represents the worst condition pavement within the community. A small full-width section should be milled and replaced in 2007 and the balance of the street is scheduled for the first repair phase in 2008.

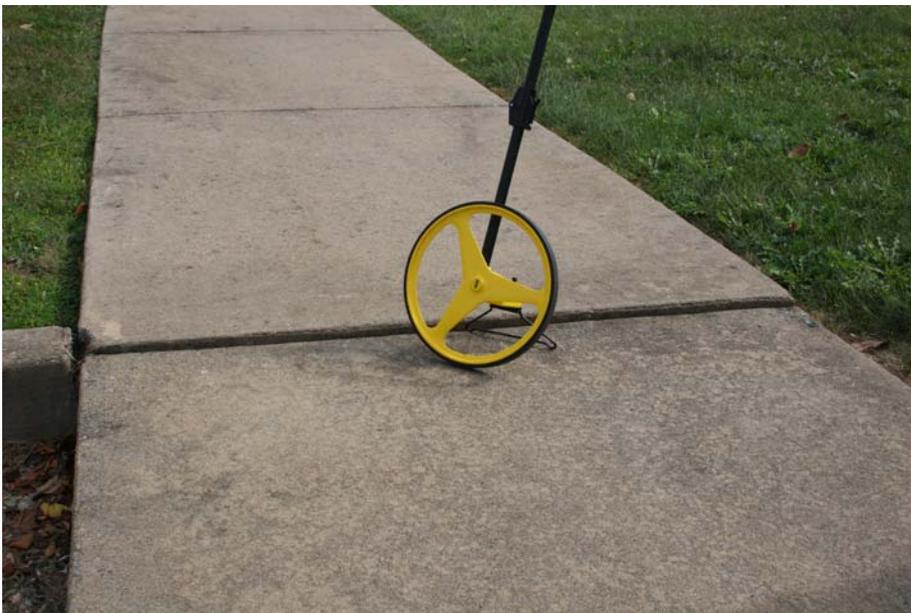
**PHOTO #6**

Differential settlement of adjacent sidewalk panels resulting in a tripping hazard requiring repair for safety liability.

**7.4 Concrete Sidewalks:** When sidewalks are cracked or scaled or sections have settled, the resulting differential or "tripping hazard" can present a liability problem for the Association if personal injury should occur as a result. Tripping hazards should be repaired expeditiously to promote safety and prevent liability problems for the community. Generally, where practical and appropriate, concrete element repairs and replacements are scheduled in the same years to promote cost efficiencies. Replacements are usually scheduled in cycles because the necessity of full replacement at one time is unlikely. Typically, damaged or differentially settled sections can be removed by saw cutting or jack hammer and re-cast. Concrete milling of the differential surfaces is sometimes an appropriate, cost-effective alternative to re-casting. Skim coating is not an effective repair for scaled or settled concrete surfaces and, over time, will usually worsen the problem.

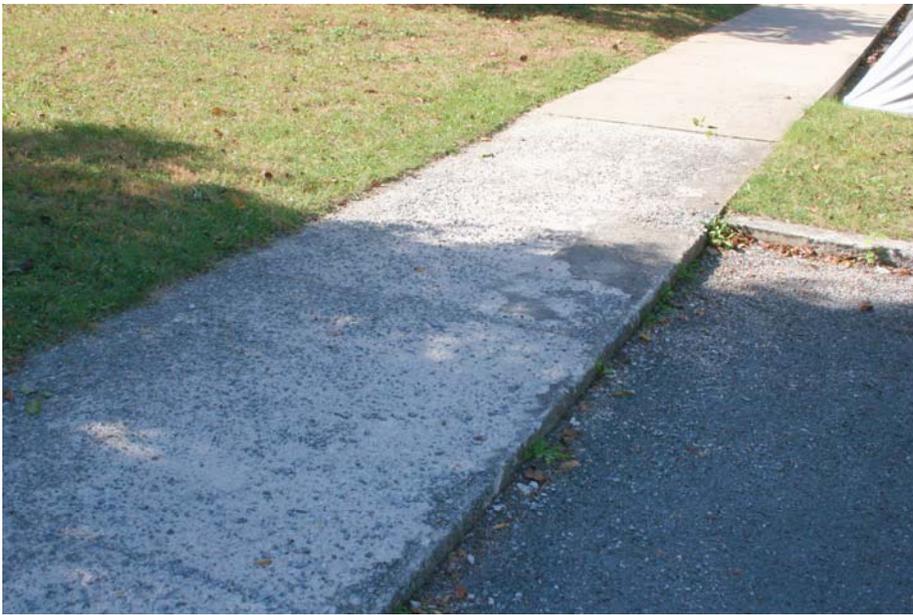
**PHOTO #7**  
Severe scaling of concrete sidewalk panels requiring replacement.

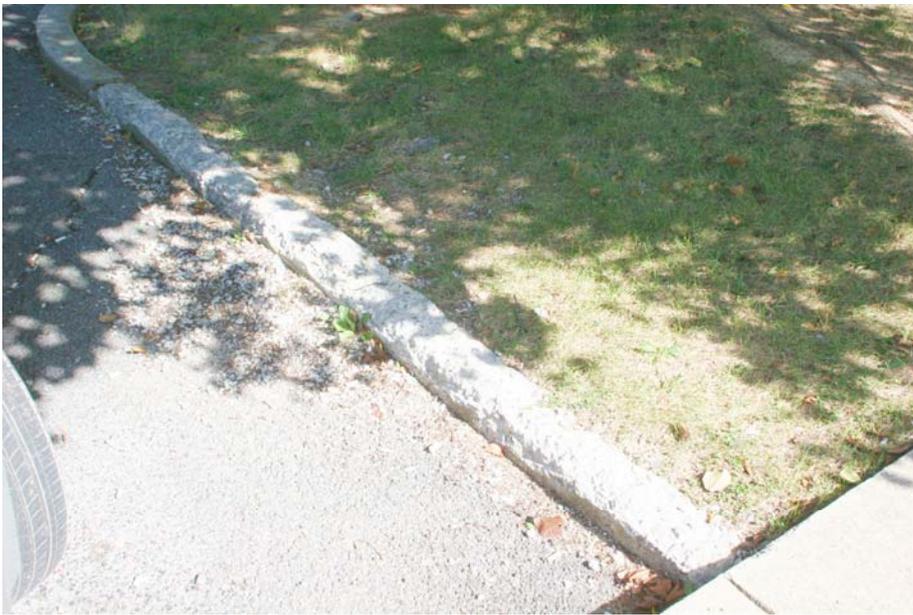
**PHOTO #8**  
Severe deterioration of concrete curb sections requiring replacement.

**7.5 Concrete Curbs and Gutters:** Vehicle impacts, differential settlement, construction damage, and cracking and spalling of the concrete will eventually result in the need for replacement of some curb sections. A typical damaged or settled section, usually 10 feet in length, will be removed by saw cutting or jack hammer and re-cast. Replacements are scheduled in cycles because the necessity of full replacement at one time is unlikely.

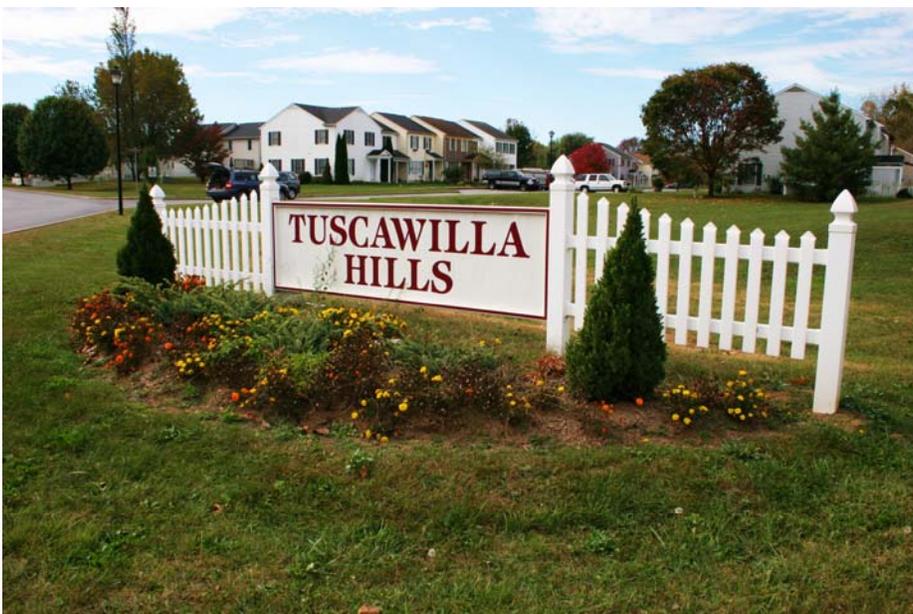
**PHOTO #9**  
Entrance features have been recently replaced with PVC materials that will provide a long service life with minimal maintenance.

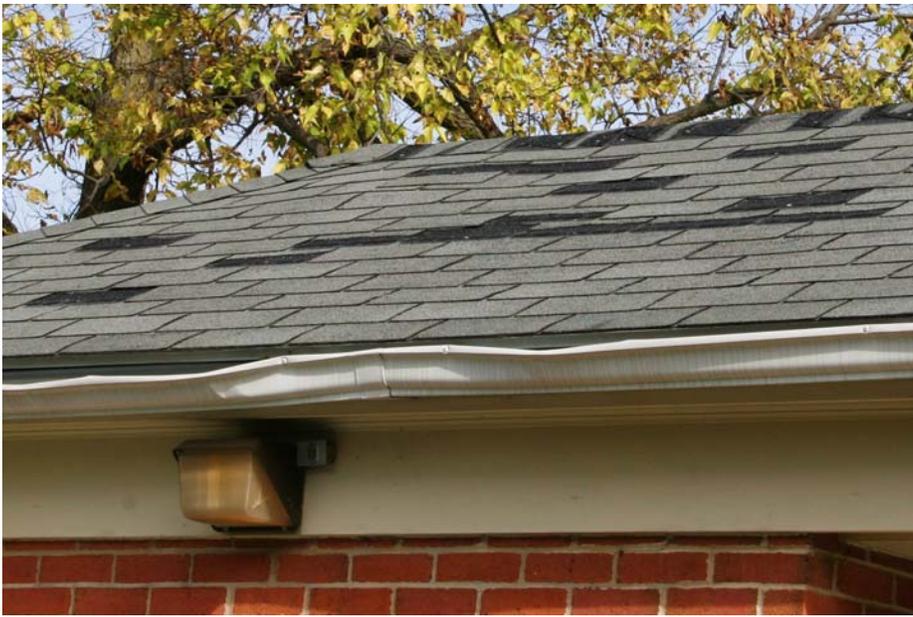
**PHOTO #10**  
The central mail station roofing is in poor condition and is scheduled for near-term replacement including gutters and downspouts.

**7.6 Composite Shingle Roofs:** Roofs should be inspected annually for damage and leaks. Loose or missing shingles should be replaced on a regular basis. Signs of deflected roof sheathing or discoloration of the sheathing are indicative of moisture problems and should be investigated. Gutters and downspouts should be inspected annually, and loose, damaged, or leaking sections should be secured, repaired, or replaced. All gutters should be kept clean of leaf material and debris. Clogged downspouts should be cleared. In areas where gutters collect fallen leaves, gutters should have screens installed. Downspouts should be directed away from buildings. Erosion can be minimized by the use of properly located splash blocks or plastic flexible tubing. In all cases, water should be directed away from building foundations. Splash blocks must be properly placed, and flexible plastic extensions require diligent maintenance.

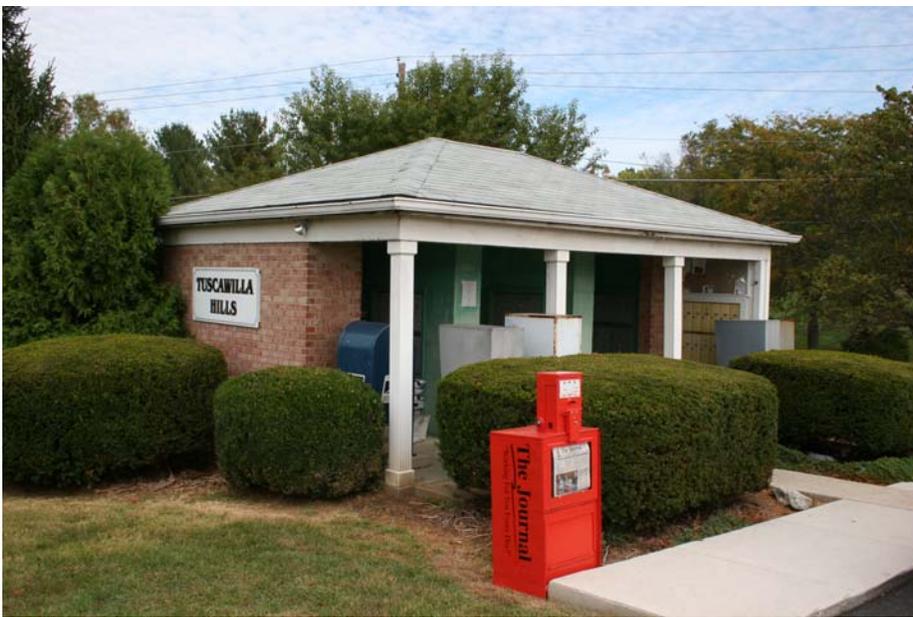
**PHOTO #11**  
The Summit Point mail station roofing appears to be replacement shingles and should provide many additional years of service.

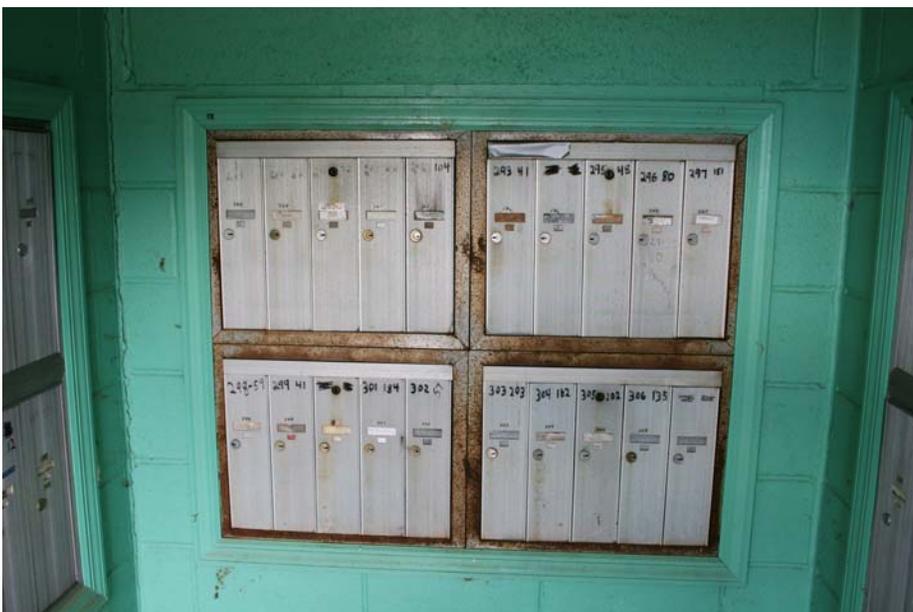
**PHOTO #12**  
Summit Point mail station boxes are in poor condition and scheduled for near-term replacement.

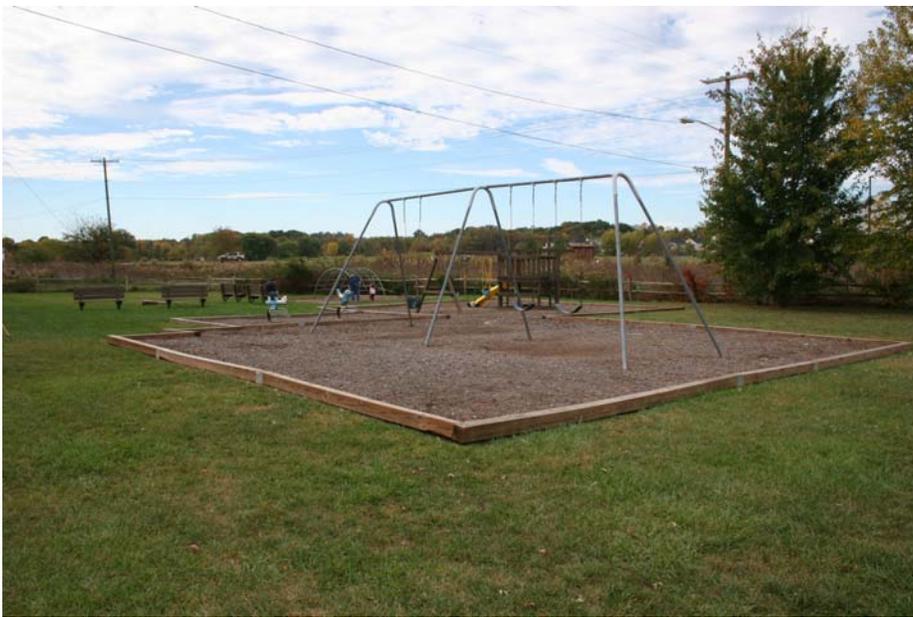
**PHOTO #13**  
Community tot lot in fair to good condition and can be utilized for many additional years.

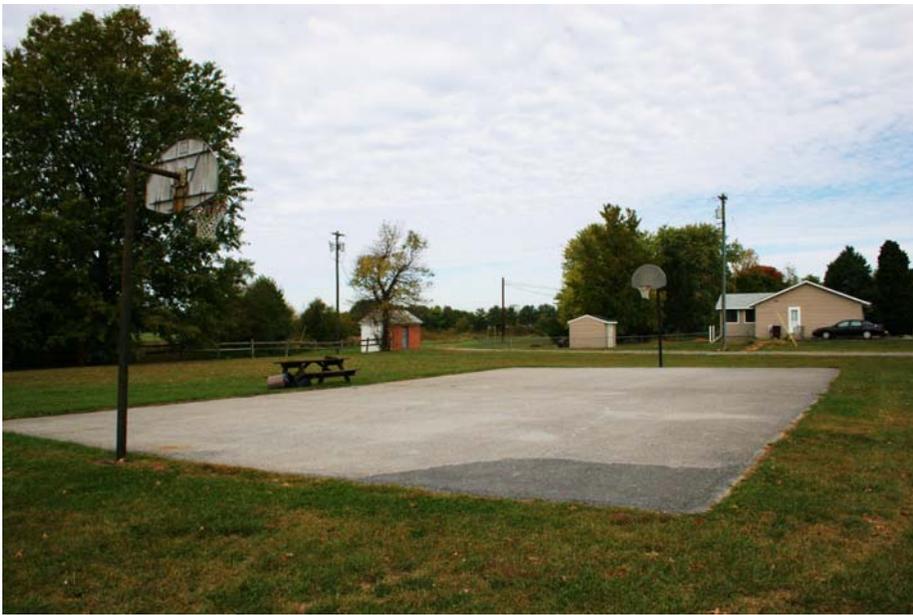
**PHOTO #14**  
The basketball court is in fair condition with patches and transverse cracks, but can be utilized for many additional years.

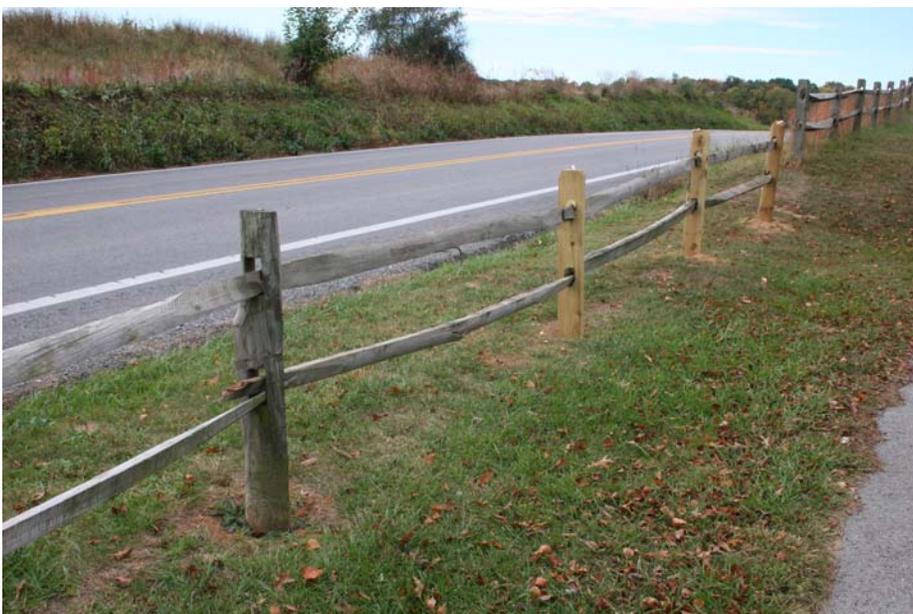
**PHOTO #15**  
Split rail fencing is being replaced on an as-needed basis, and we have continued with this approach.
