Condition Assessment
and
Reserve Fund Plan Update
2012

**TUSCAWILLA
HILLS**

Charles Town, West Virginia

September 30, 2011

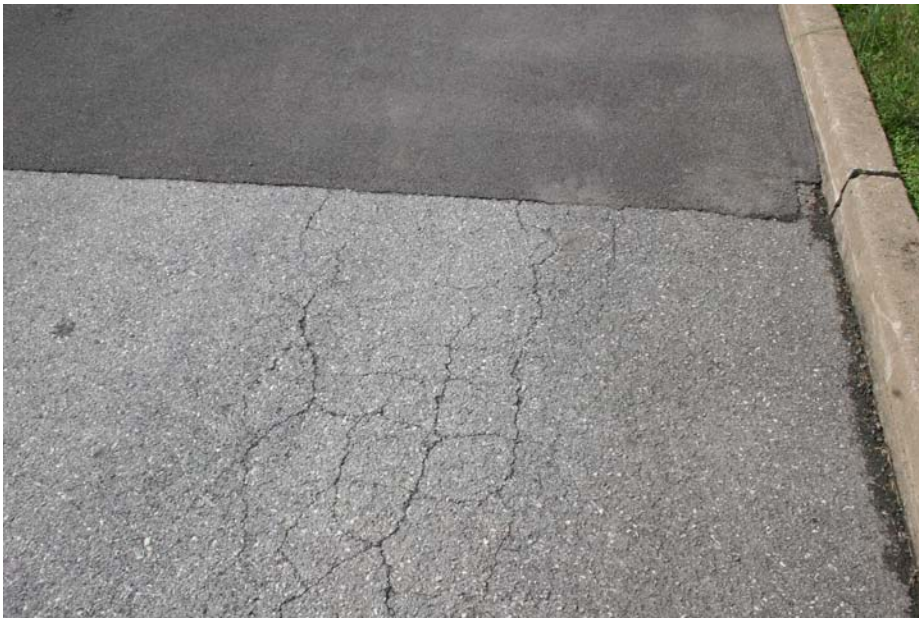
PHOTO #1
Here is an example, where, in proximity of recent overlay repair, there is additional damage now extending beyond the original overlay, as deflection continues.

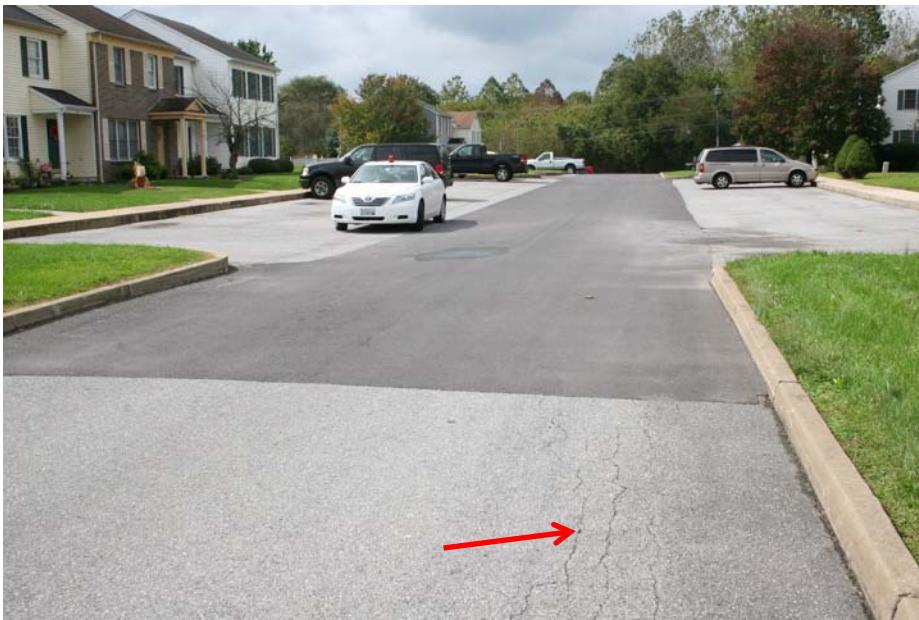
PHOTO #2
In the same area this shows the extent of the additional deflection beyond the overlay.

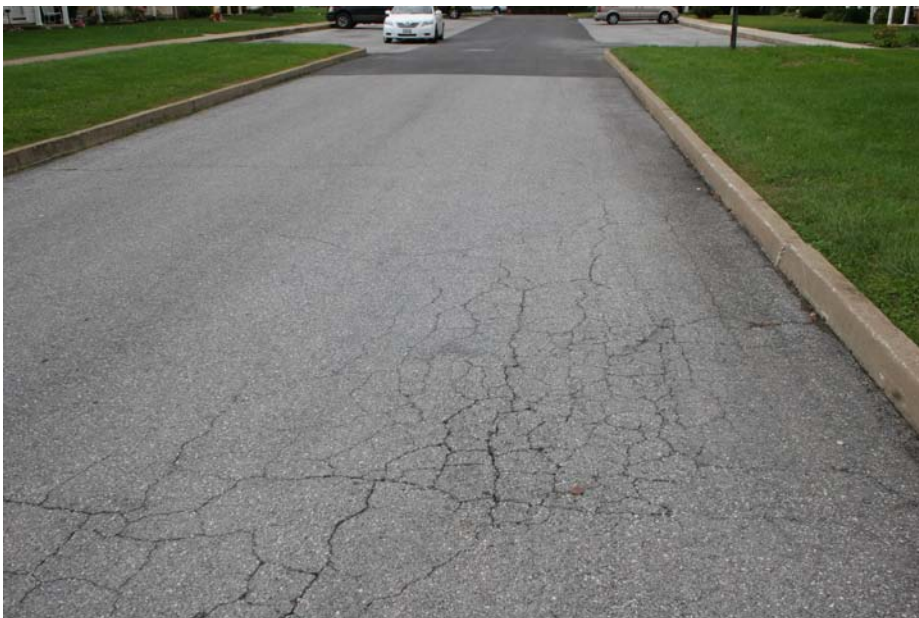
PHOTO #3
Further down the same street, new deflection is now present where none existed four years ago.

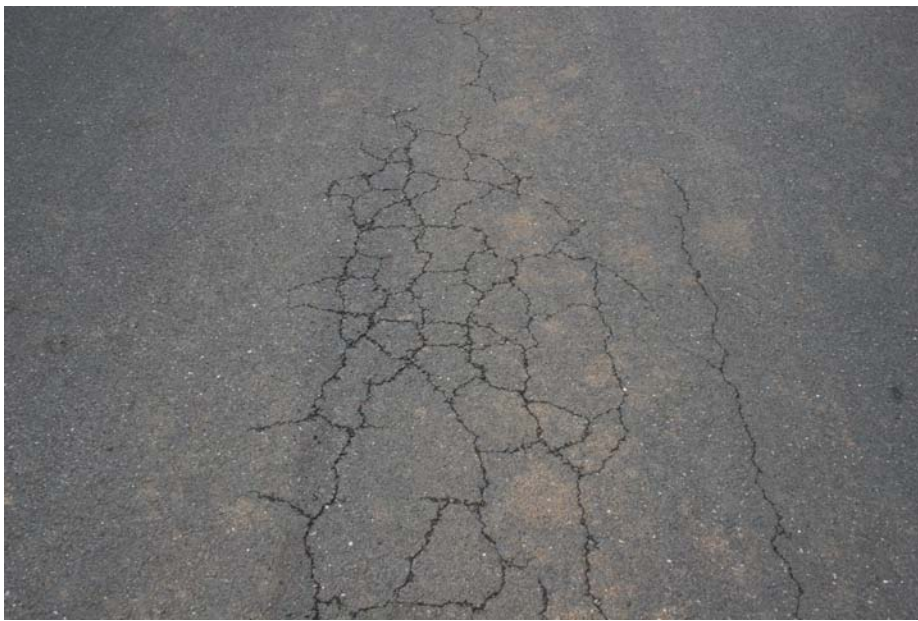
PHOTO #4

This deflection is on Tall Oak Drive, which is a section that was a recent overlay repair prior to 2007. This classic reflective cracking indicates poor pavement that was simply overlaid.

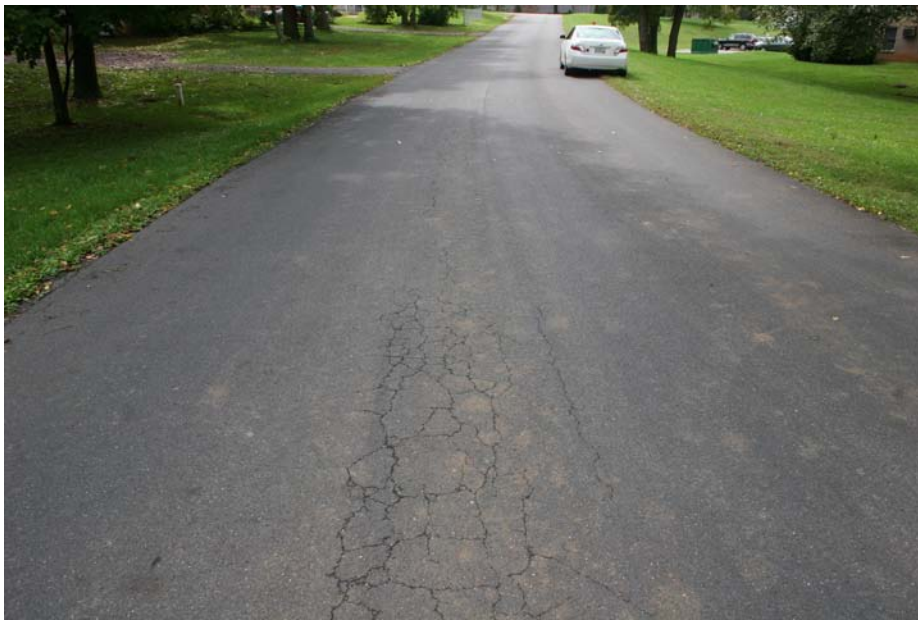
PHOTO #5

This is an overview of the section of Tall Oak Drive with the pre-2007 overlay. Note that beginning deflection is present along significant portions of it.

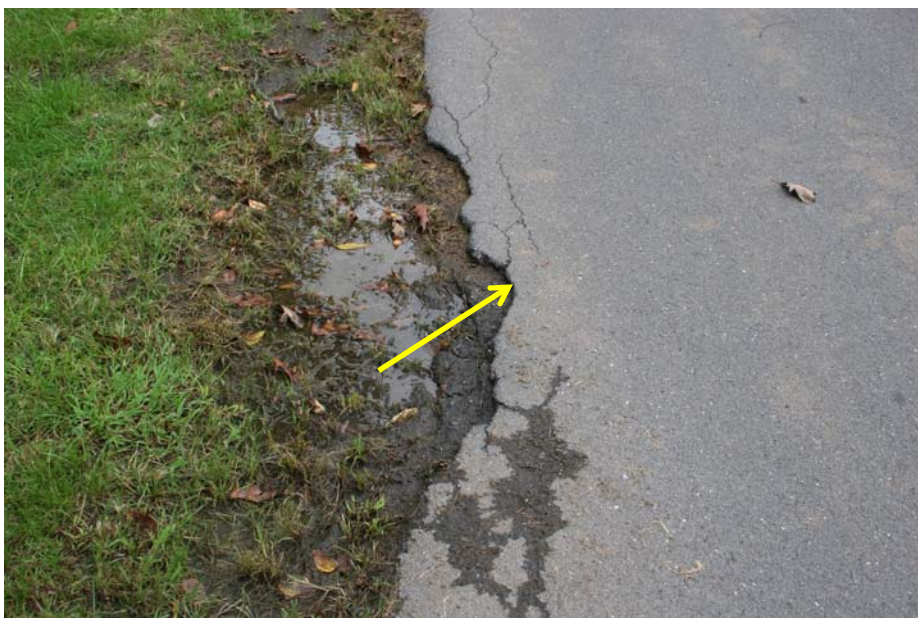
PHOTO #6

The arrow indicates an overlay thickness of less than 1 1/2", which may be the reason that the Tall Oak Drive section is now beginning to fail. This edge damage should be repaired in the 2014 repair cycle.

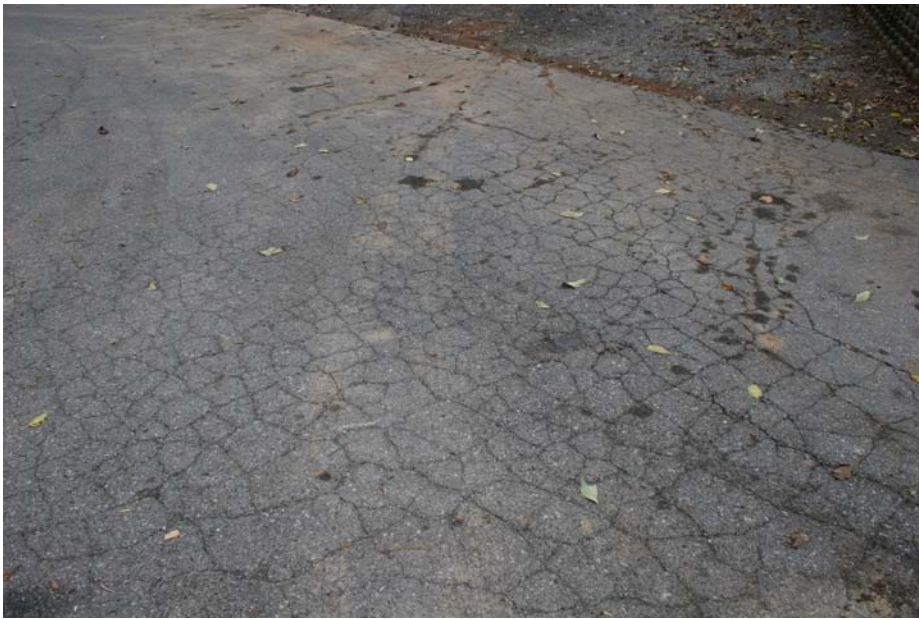
PHOTO #7

This is the worst damage, which has occurred since 2007 on the Douglas Drive cul de sac. This section is scheduled for repair in 2012.

Street Name	Mill and Replace SY	
6. Berkeley Court	367	
15. Douglas Drive *	867	
TOTAL	1,234	1%

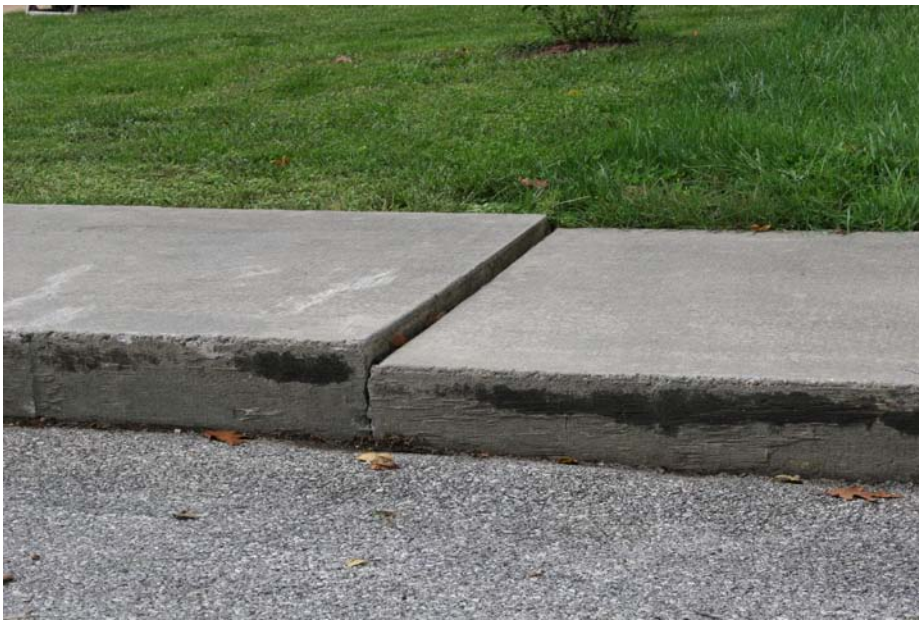
PHOTO #8

This is an example of differential settlement of adjacent sidewalk panels resulting in a tripping hazard requiring repair.

6.4 Concrete Sidewalks: When sidewalks are cracked or scaled or sections have settled, the resulting differential or “tripping hazard” can present a liability problem for the Association if personal injury should occur as a result. Tripping hazards should be repaired expeditiously to promote safety and prevent liability problems for the community. Generally, where practical and appropriate, concrete element repairs and replacements are scheduled in the same years to promote cost efficiencies. Replacements are usually scheduled in cycles because the necessity of full replacement at one time is unlikely. Typically, damaged or differentially settled sections can be removed by saw cutting or jack hammer and re-cast. Concrete milling of the differential surfaces is sometimes an appropriate, cost-effective alternative to re-casting. Skim coating is not an effective repair for scaled or settled concrete surfaces and, over time, will usually worsen the problem.

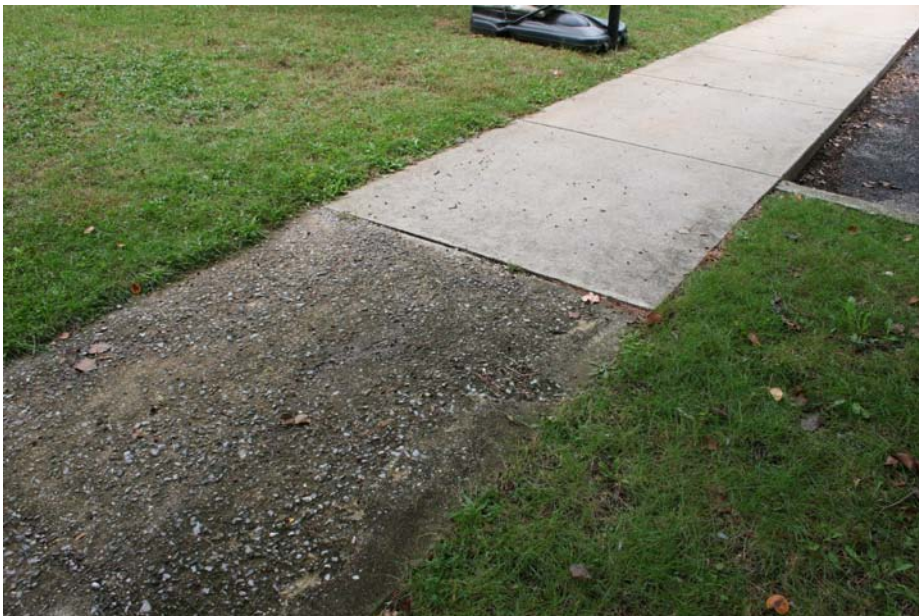
PHOTO #9

This is an example of severe surface scaling of a sidewalk panel requiring replacement.

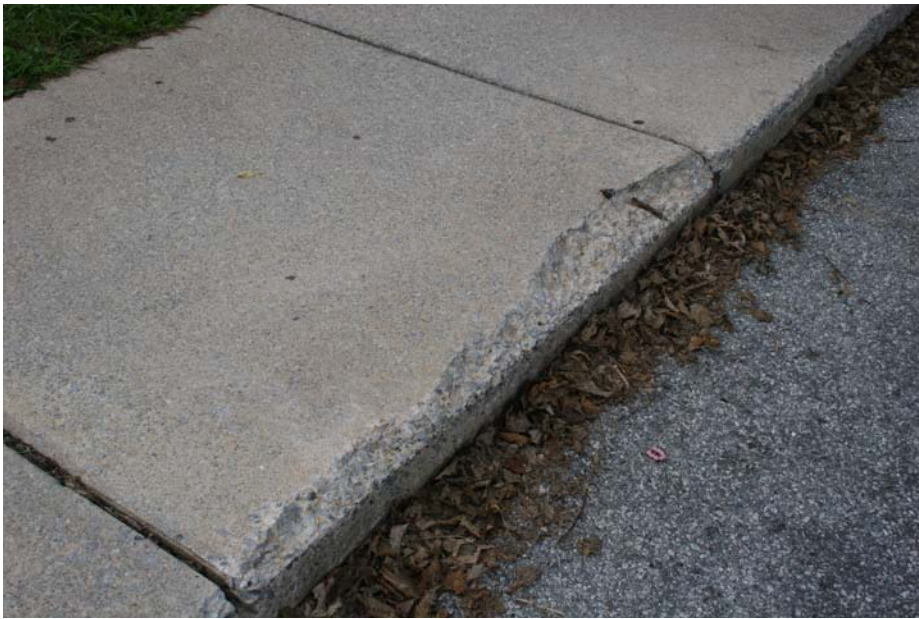
PHOTO #10

This is impact damage of sidewalk panels near the Central Mail Station. This type of deficiency could be a potential tripping hazard.

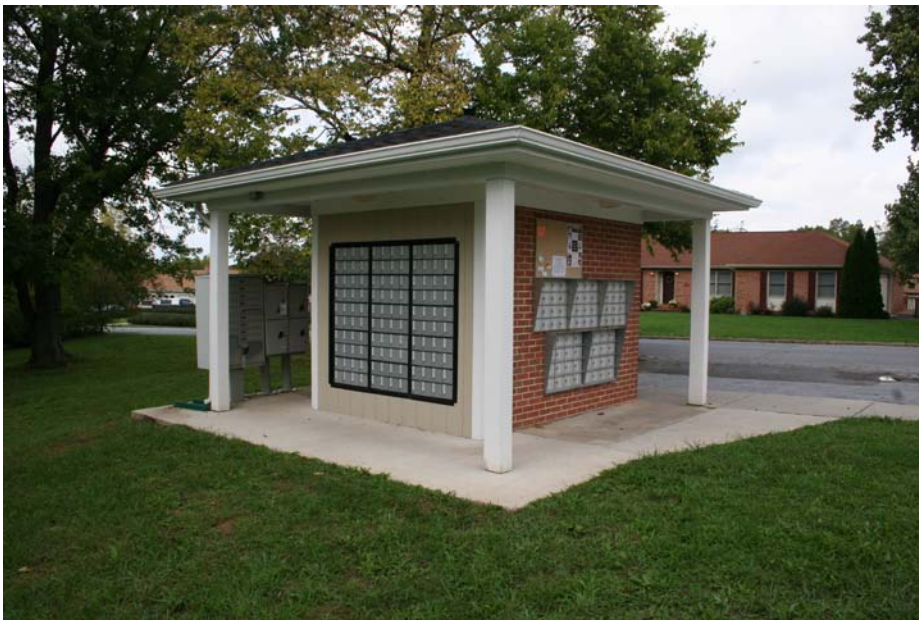
PHOTO #11

3.2	Central Mail Station Re-Roofing	205	SF	\$5.75	\$1,179	20	2028	100%	\$1,892	2048	100%	\$3,416				The 3/12 pitched roof has an asphalt shingle covering, which has recently been replaced and is in good condition. Pre-finished replacement aluminum gutters and downspouts are installed at roof terminations and are in good condition. Re-roofing projects include replacement of shingles, deteriorated sheathing, and gutters and downspouts.

This is an overview of the Central Mail Station with new roofing and enlarged box facility. The structure should provide many additional service years with the repairs and improvements.

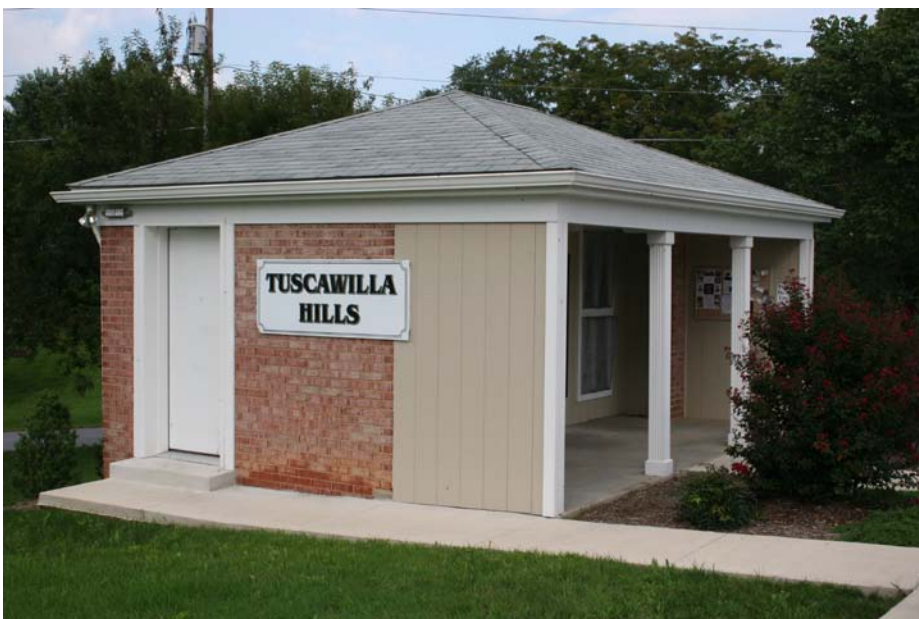
PHOTO #12

3.4	Summit Point Mail Station Re-Roofing	436	SF	\$5.75	\$2,507	20	2023	100%	\$3,470	2043	100%	\$6,268				The 3/12 pitched roof has an asphalt shingle covering. It appears to be in continuing good condition with no deteriorated shingles or deflection of the roof sheathing observed. Pre-finished aluminum gutters and downspouts are installed at all roof terminations. Downspouts appear to be properly directed away from building foundations. All components appear to be in good condition. Re-roofing projects include replacement of shingles, deteriorated sheathing, and gutters and downspouts.

This is an overview of the Summit Point Mail Station with enlarged box facility and new carrier entrance. The structure should provide many additional service years with the repairs and improvements.

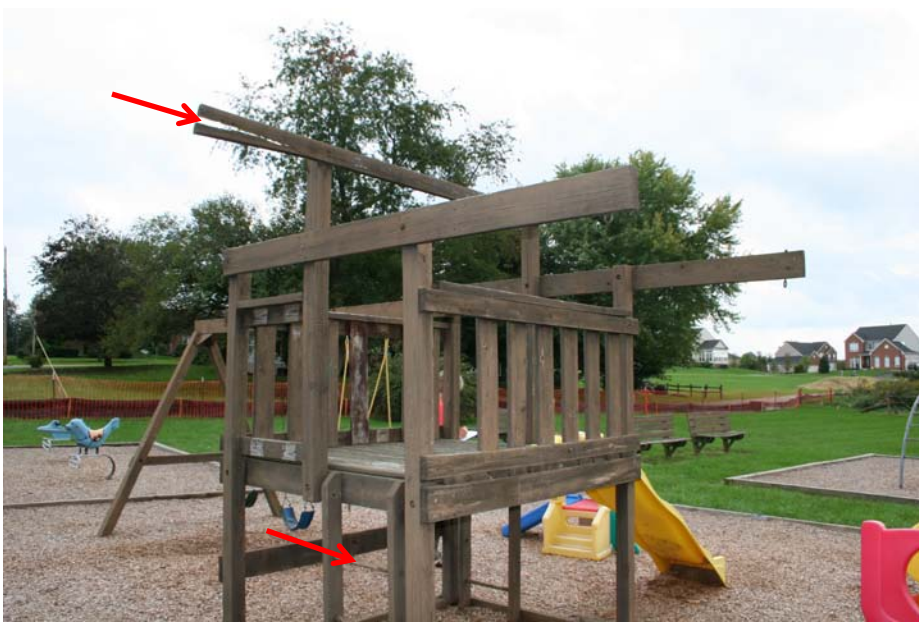
The tot lot border has been replaced and is in good condition. Metal equipment is in continuing good condition and is capable of many additional years of service. The wood play components are in poor condition and should be replaced or removed near-term.

PHOTO #13
The wood play module is at the end of its service life and should be replaced for safety.

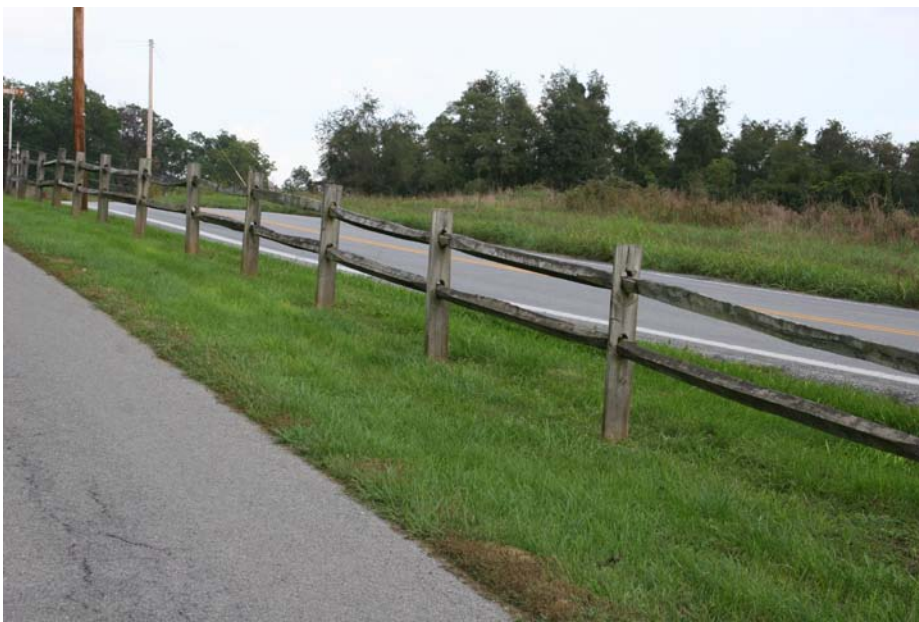
3.9	Split-Rail Fencing	1,916	LF	\$13.00	\$24,908	20	2014	10%	\$2,642	2017	10%	\$2,888	2020	10%	\$3,155	Wood split-rail fencing is constructed adjacent to the perimeter at Summit Point Road. We understand that components from the main entrance fencing, that was replaced with vinyl fencing, was used to replace deteriorated timbers and posts. The fencing generally appear to be in good condition. This category includes smaller sections of fencing located throughout the community, most of which appear to be somewhat deteriorated. We have budgeted a periodic allowance to address repairs/replacements as necessary.

PHOTO #14
Split-rail fencing has benefitted from supplements from other fencing that was removed and replaced by vinyl fencing.

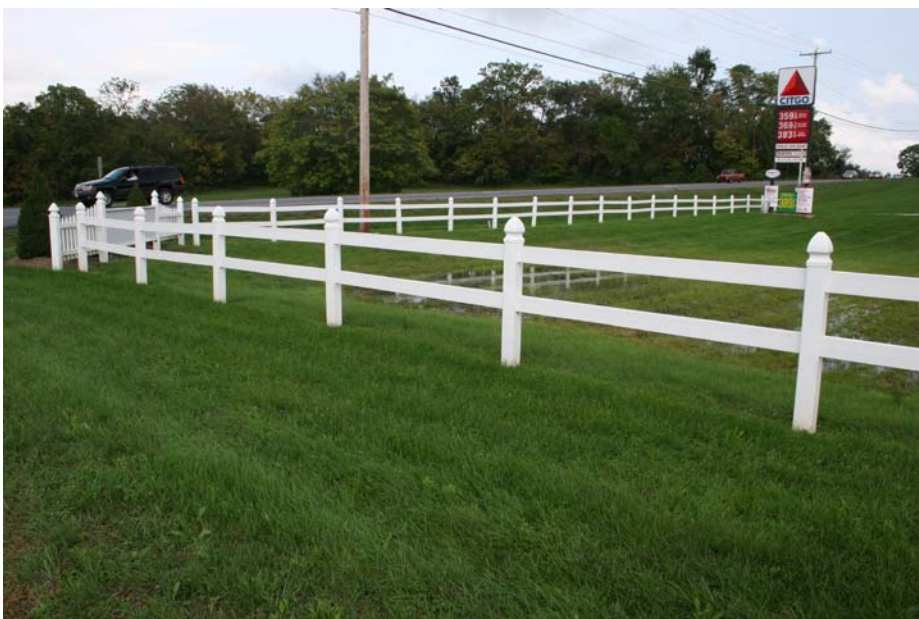
3.10	Vinyl Fencing	264	LF	\$10.25	\$2,706	30	2041	100%	\$6,377							Vinyl three-rail fencing has been installed replacing the split rail fencing adjacent to the entrance signs and at another perimeter location at Fenway Drive. All components appear to be in good condition and should provide a long service life with little or no maintenance other than replacing or repairing damaged components.

PHOTO #15
This the new replacement vinyl fencing that has been installed at the entrance and at Fenway Drive.
