Condition Assessment
and
Reserve Fund Plan Update
2012

**TUSCAWILLA
HILLS**

Charles Town, West Virginia

September 30, 2011

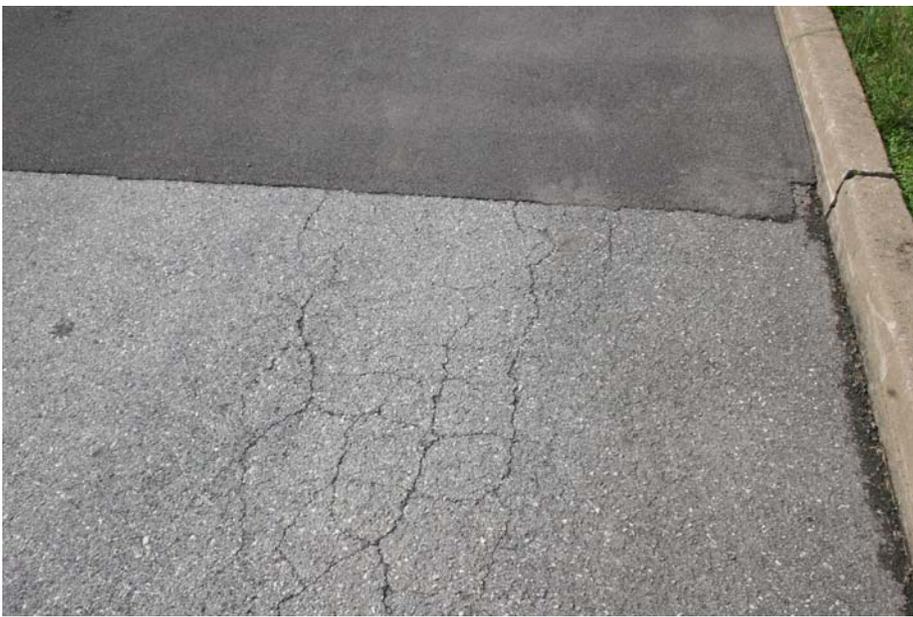
PHOTO #1
Here is an example, where, in proximity of recent overlay repair, there is additional damage now extending beyond the original overlay, as deflection continues.

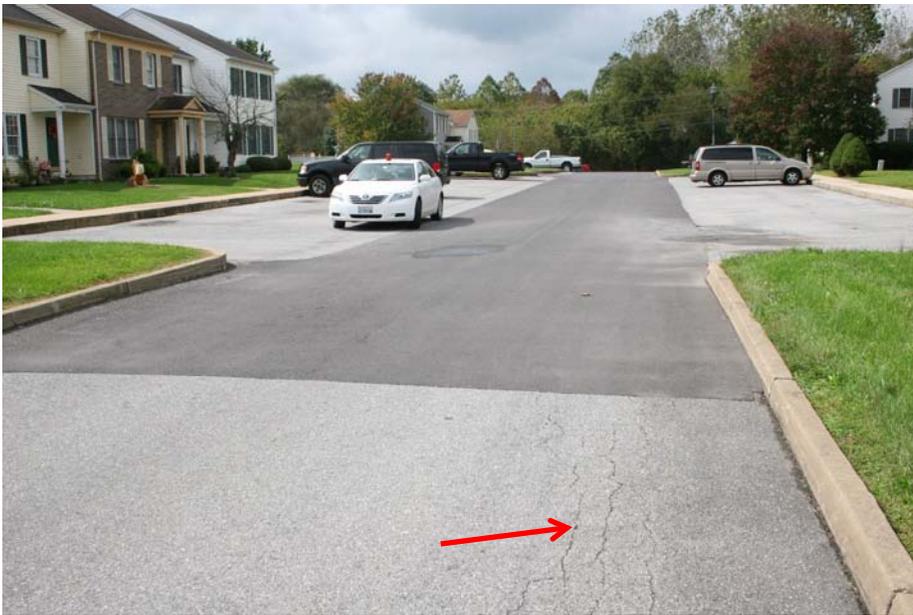
PHOTO #2
In the same area this shows the extent of the additional deflection beyond the overlay.

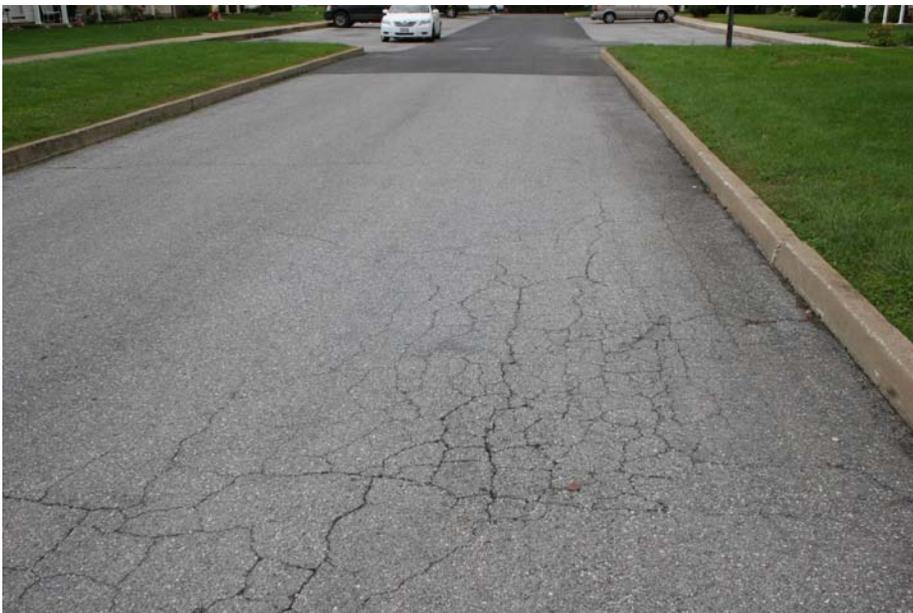
PHOTO #3
Further down the same street, new deflection is now present where none existed four years ago.

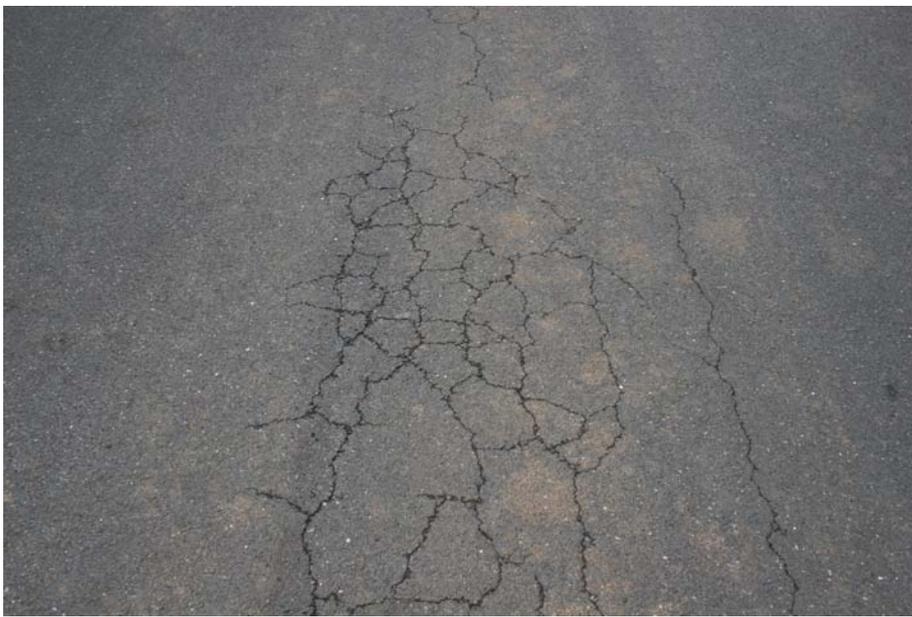
PHOTO #4

This deflection is on Tall Oak Drive, which is a section that was a recent overlay repair prior to 2007. This classic reflective cracking indicates poor pavement that was simply overlaid.

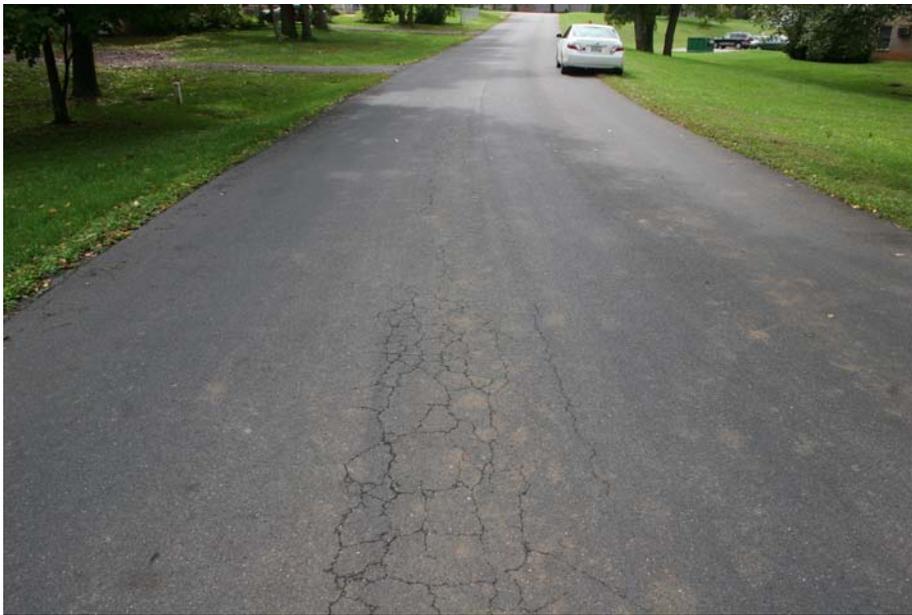
PHOTO #5

This is an overview of the section of Tall Oak Drive with the pre-2007 overlay. Note that beginning deflection is present along significant portions of it.

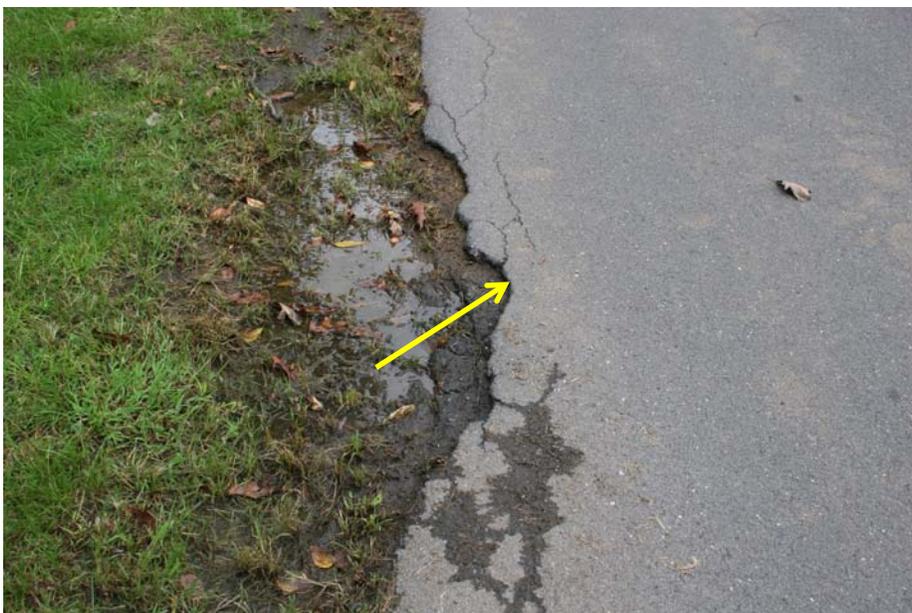
PHOTO #6

The arrow indicates an overlay thickness of less than 1 1/2", which may be the reason that the Tall Oak Drive section is now beginning to fail. This edge damage should be repaired in the 2014 repair cycle.

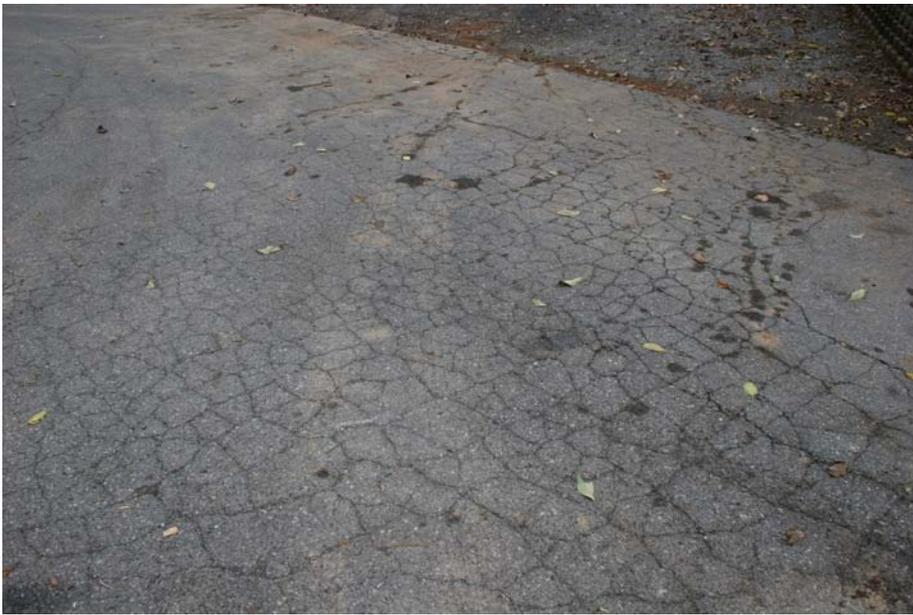
PHOTO #7
This is the worst damage, which has occurred since 2007 on the Douglas Drive cul de sac. This section is scheduled for repair in 2012.

Street Name	Mill and Replace SY	
6. Berkeley Court	367	
15. Douglas Drive *	867	
TOTAL	1,234	1%

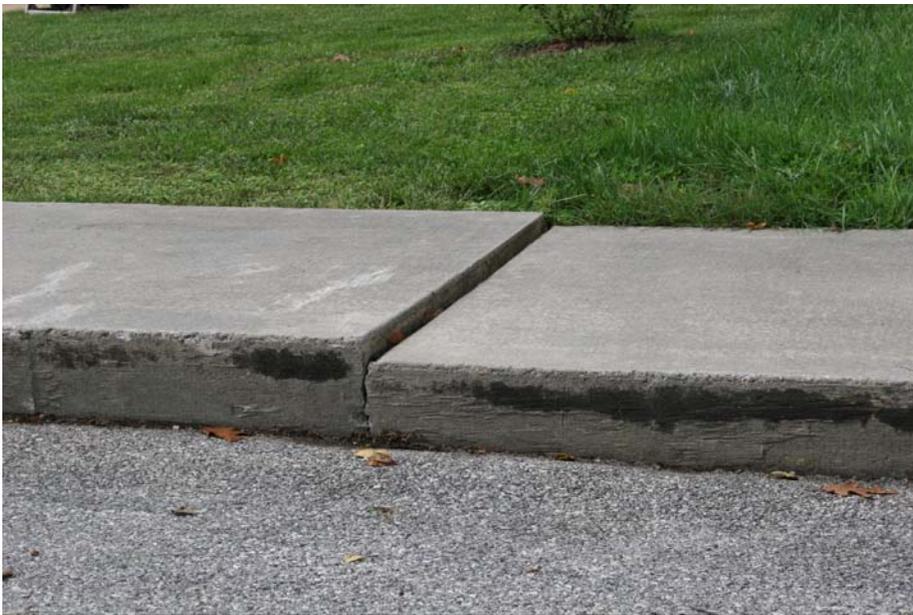
PHOTO #8
This is an example of differential settlement of adjacent sidewalk panels resulting in a tripping hazard requiring repair.

6.4 Concrete Sidewalks: When sidewalks are cracked or scaled or sections have settled, the resulting differential or “tripping hazard” can present a liability problem for the Association if personal injury should occur as a result. Tripping hazards should be repaired expeditiously to promote safety and prevent liability problems for the community. Generally, where practical and appropriate, concrete element repairs and replacements are scheduled in the same years to promote cost efficiencies. Replacements are usually scheduled in cycles because the necessity of full replacement at one time is unlikely. Typically, damaged or differentially settled sections can be removed by saw cutting or jack hammer and re-cast. Concrete milling of the differential surfaces is sometimes an appropriate, cost-effective alternative to re-casting. Skim coating is not an effective repair for scaled or settled concrete surfaces and, over time, will usually worsen the problem.

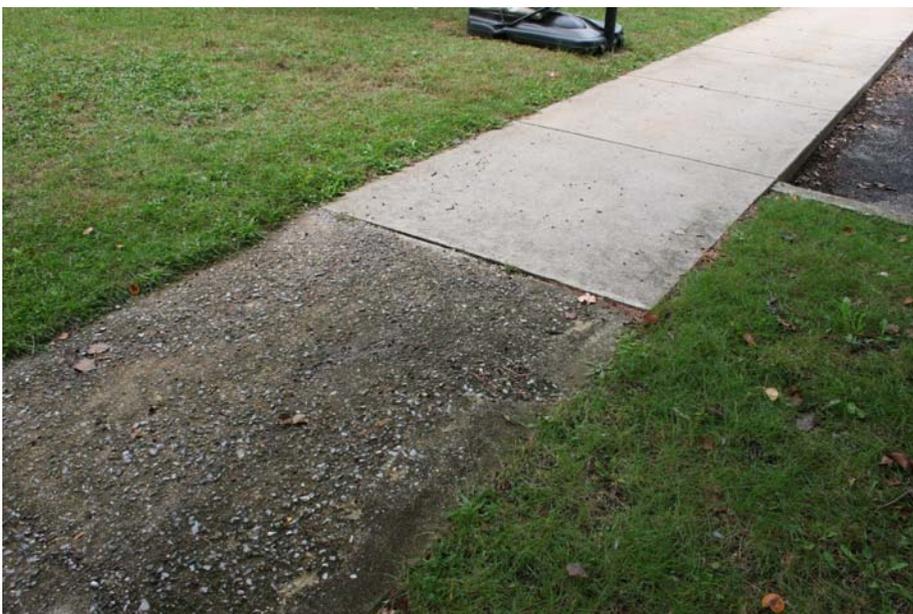
PHOTO #9
This is an example of severe surface scaling of a sidewalk panel requiring replacement.

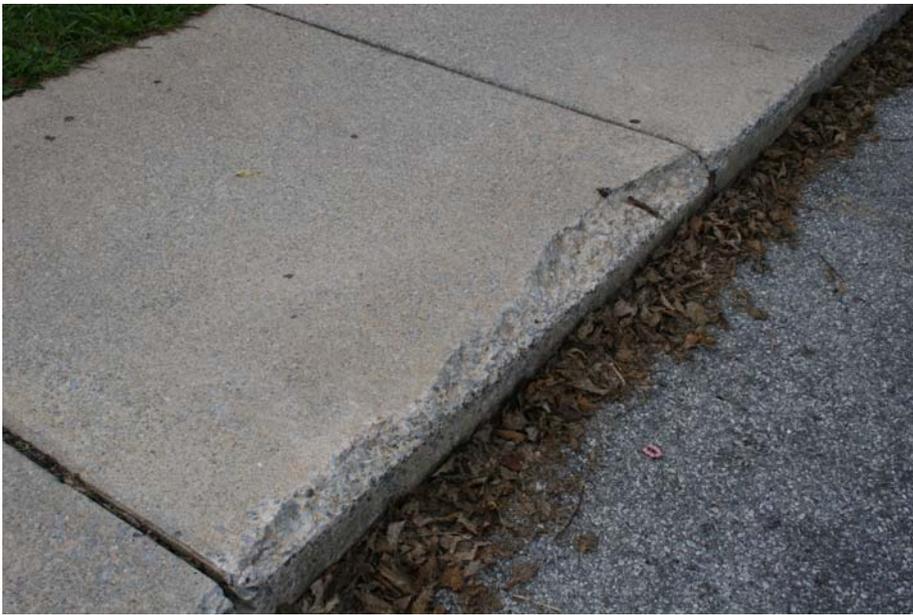
PHOTO #10

This is impact damage of sidewalk panels near the Central Mail Station. This type of deficiency could be a potential tripping hazard.

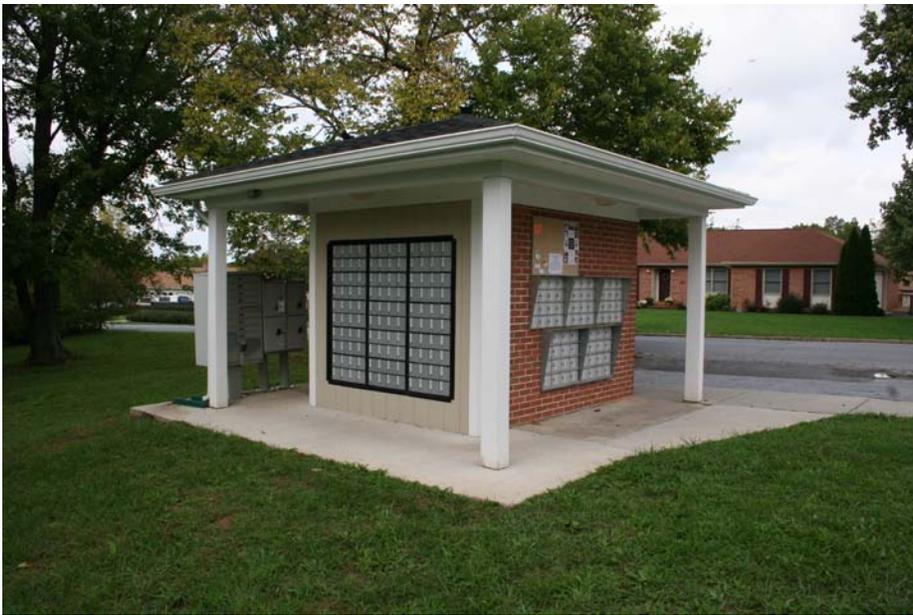
PHOTO #11

3.2	Central Mail Station Re-Roofing	205	SF	\$5.75	\$1,179	20	2028	100%	\$1,892	2048	100%	\$3,416				The 3/12 pitched roof has an asphalt shingle covering, which has recently been replaced and is in good condition. Pre-finished replacement aluminum gutters and downspouts are installed at roof terminations and are in good condition. Re-roofing projects include replacement of shingles, deteriorated sheathing, and gutters and downspouts.

This is an overview of the Central Mail Station with new roofing and enlarged box facility. The structure should provide many additional service years with the repairs and improvements.

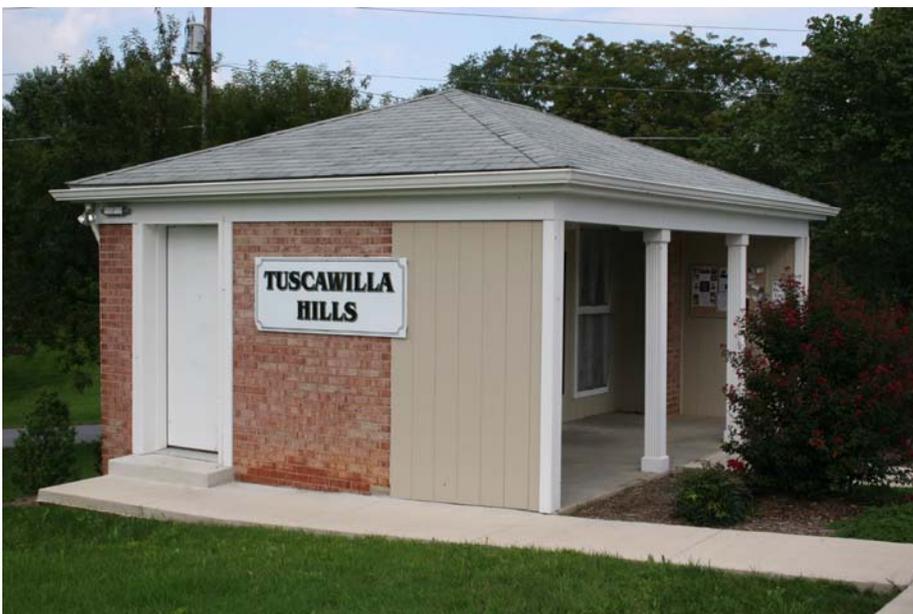
PHOTO #12

3.4	Summit Point Mail Station Re-Roofing	436	SF	\$5.75	\$2,507	20	2023	100%	\$3,470	2043	100%	\$6,268				The 3/12 pitched roof has an asphalt shingle covering. It appears to be in continuing good condition with no deteriorated shingles or deflection of the roof sheathing observed. Pre-finished aluminum gutters and downspouts are installed at all roof terminations. Downspouts appear to be properly directed away from building foundations. All components appear to be in good condition. Re-roofing projects include replacement of shingles, deteriorated sheathing, and gutters and downspouts.

This is an overview of the Summit Point Mail Station with enlarged box facility and new carrier entrance. The structure should provide many additional service years with the repairs and improvements.

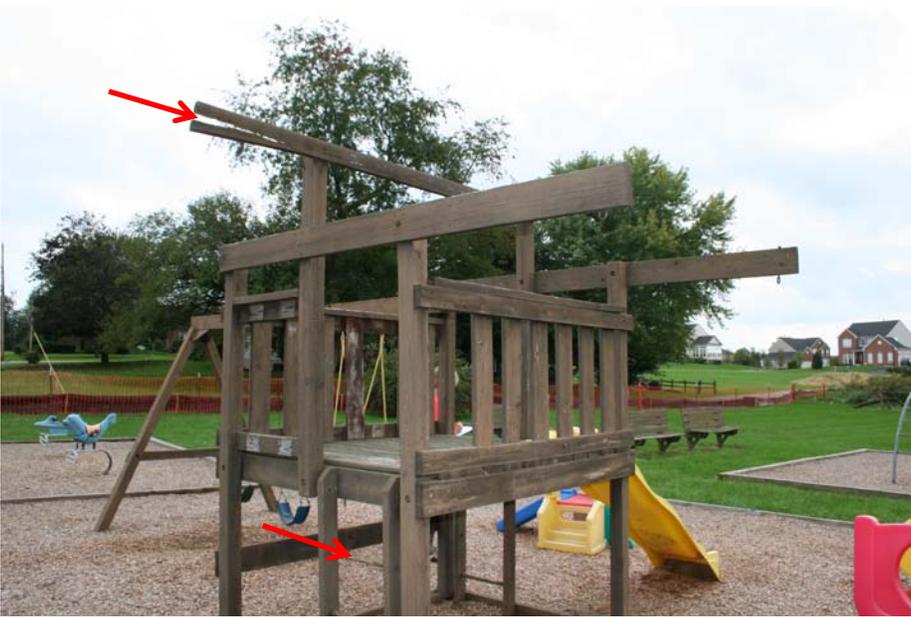
The tot lot border has been replaced and is in good condition. Metal equipment is in continuing good condition and is capable of many additional years of service. The wood play components are in poor condition and should be replaced or removed near-term.

PHOTO #13
The wood play module is at the end of its service life and should be replaced for safety.

3.6	Tot Lot & Outdoor Furniture	1	LS	\$29,200.00	\$29,200	15	2012	55%	\$16,060	2027	100%	\$45,493	2042	100%	\$70,876	One tot lot is located within the community. Equipment consists of new wood borders in good condition, a metal swing set and climbing dome in continuing good condition, wood benches and two spring toys in continuing good condition, and a small wood post play module that has deteriorated significantly since the previous evaluation. We observed weakened and one missing ladder rung and warped and split wood components. We have budgeted a near-term percentage for replacement of the play module with costs are based on replacement with U.S. Consumer Product Safety Commission (CPSC)-compliant play modules. Preventive maintenance will improve appearance and extend the useful service lives of tot lot components. Frequent, periodic safety checks of all components should be conducted to prevent personal injury.

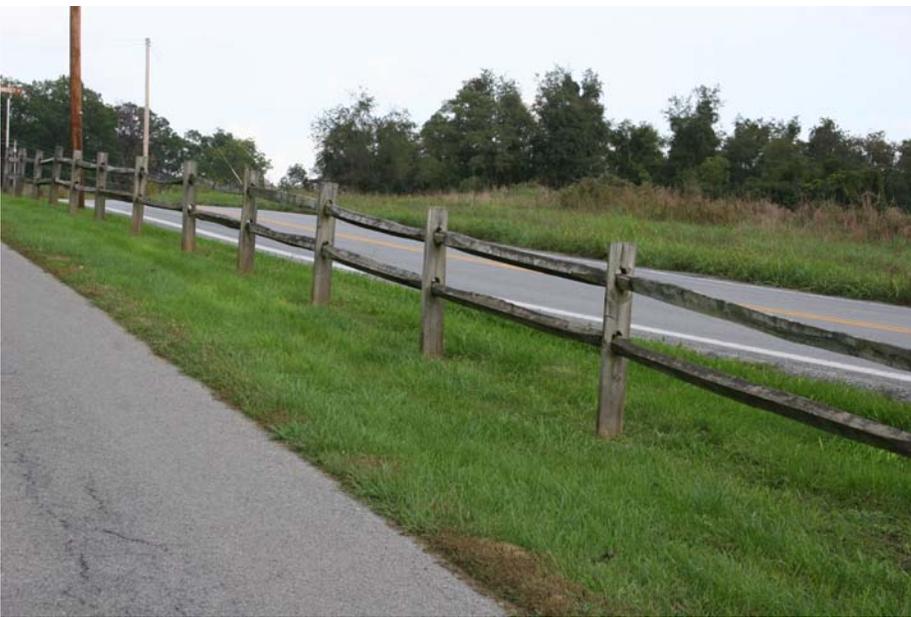
3.9	Split-Rail Fencing	1,916	LF	\$13.00	\$24,908	20	2014	10%	\$2,642	2017	10%	\$2,888	2020	10%	\$3,155	Wood split-rail fencing is constructed adjacent to the perimeter at Summit Point Road. We understand that components from the main entrance fencing, that was replaced with vinyl fencing, was used to replace deteriorated timbers and posts. The fencing generally appear to be in good condition. This category includes smaller sections of fencing located throughout the community, most of which appear to be somewhat deteriorated. We have budgeted a periodic allowance to address repairs/replacements as necessary.

PHOTO #14
Split-rail fencing has benefitted from supplements from other fencing that was removed and replaced by vinyl fencing.

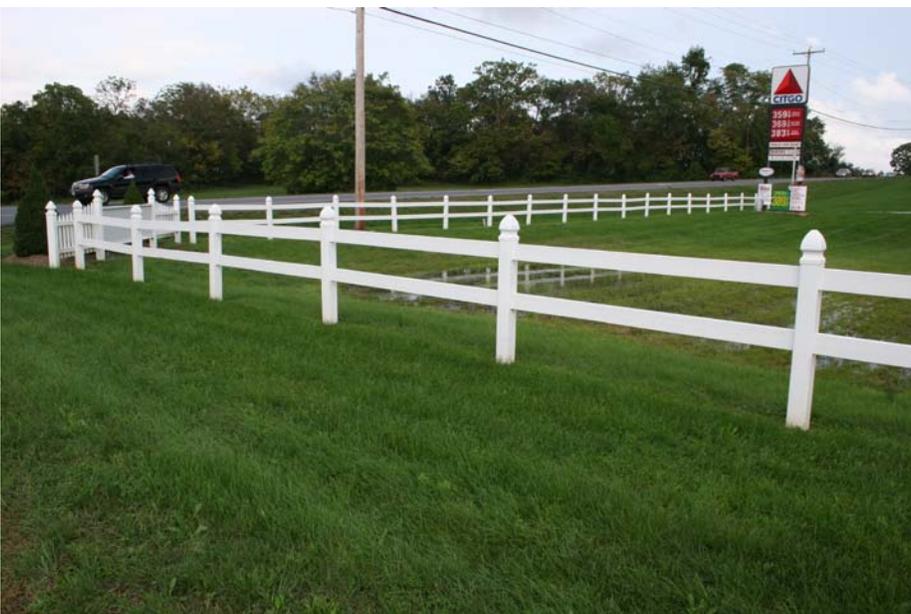
3.10	Vinyl Fencing	264	LF	\$10.25	\$2,706	30	2041	100%	\$6,377							Vinyl three-rail fencing has been installed replacing the split rail fencing adjacent to the entrance signs and at another perimeter location at Fenway Drive. All components appear to be in good condition and should provide a long service life with little or no maintenance other than replacing or repairing damaged components.

PHOTO #15
This the new replacement vinyl fencing that has been installed at the entrance and at Fenway Drive.
